## Laboratory Performance of Wicking Fabric H2Ri in Silty Gravel, Sand and Organic Silt

Billy Connor, P.E.  
Xiong Zhang, P.E., Ph.D.  
University of Alaska Fairbanks

May 2016

INE/AUTC 16.04

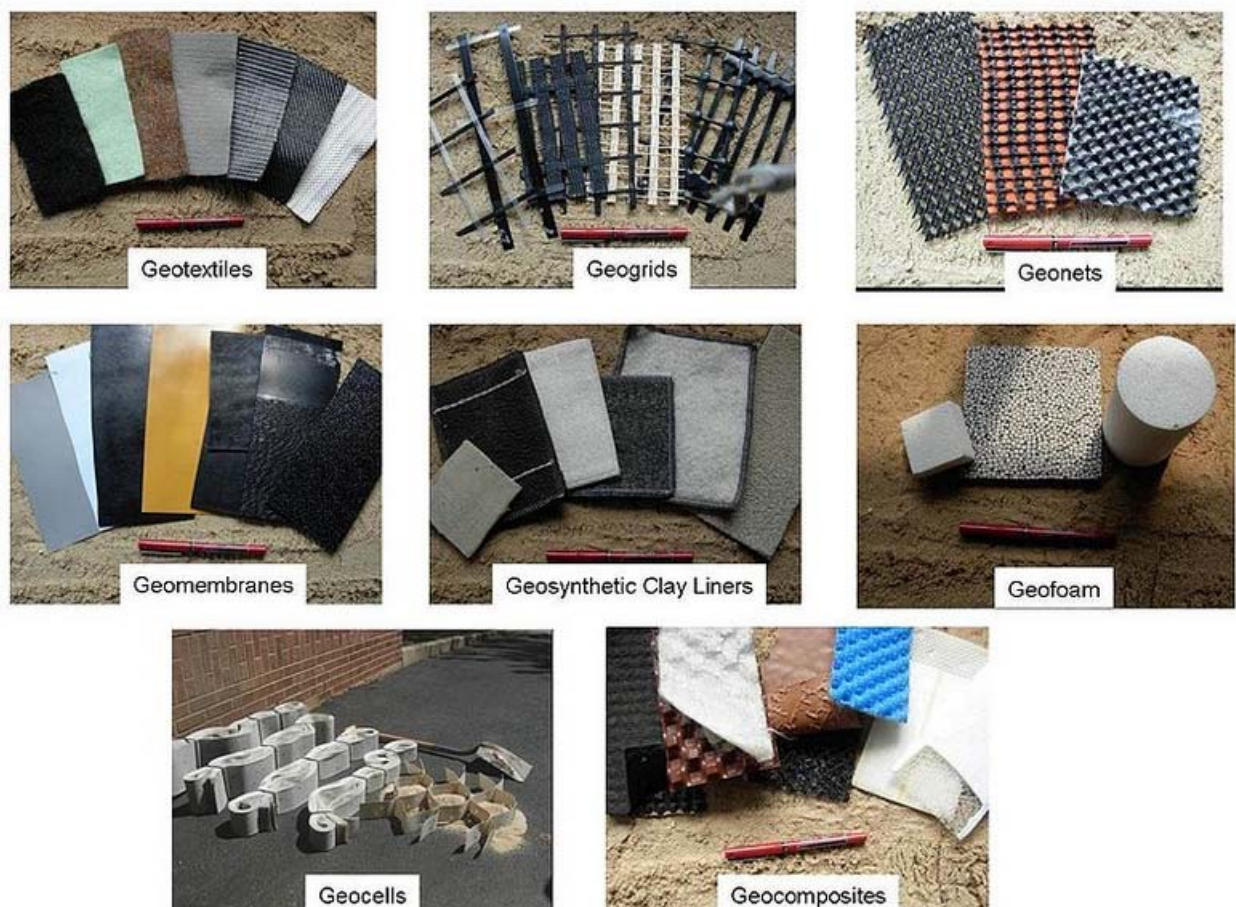
**Figure 2.8** Geosynthetic categories

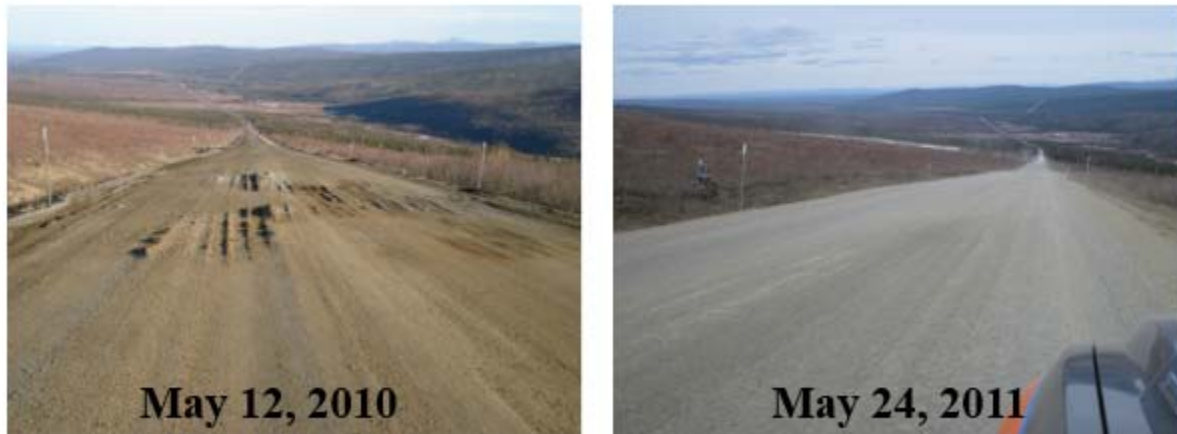
**Figure 2.15** Test section comparison

In summary, over 2 years of monitoring shows good overall performance of the testing section. Field observation clearly showed a road surface difference between sections with and without geotextile, as shown in Figure 2.15. No soft spots have been observed during early springs, and soil at the shoulders is damp, which indicates that water flows along the direction of the geotextile wicking fabric. The geotextile successfully eliminated weakening of the structural section due to excess water during the spring. Even though soil 4.5 feet beneath the surface and lower showed the existence of excess water, the soil at that point is beyond the depth of frost heave and thaw

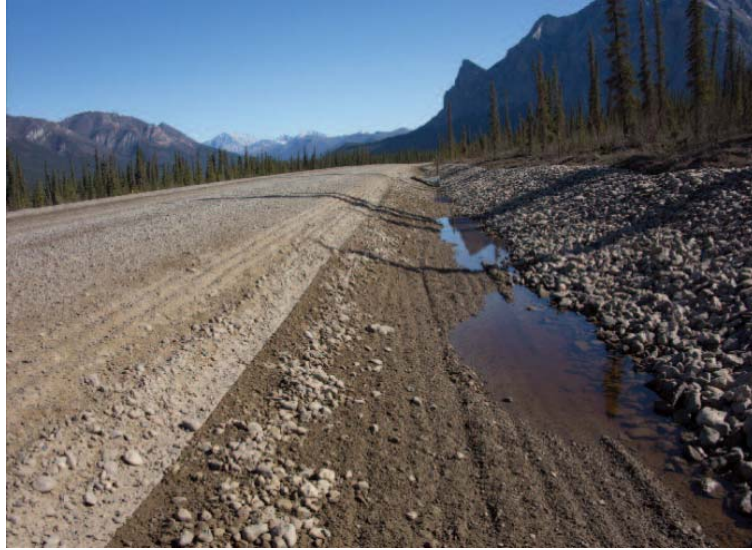
**Figure 2.16** Preliminary field observation at Coldfoot, Alaska

Frost heave problems similar to Beaver Slide occurred in a harsh environment about 30 miles north of Coldfoot, Alaska. The road is located in an area of extremely cold winter temperatures. A 12-mile test section (6 miles with geotextile material and 6 miles without) was constructed in 2012 in an effort to mitigate the frost heaving and prevent ice lens formation. Twelve inches of aggregate over the geotextile was completed on one lane first. Then the other lane was constructed using the same structure with a minimum of 1.5 feet of geotextile overlap. The goal was to reduce the weakening of the upper 1.5 feet of material which carries 80% of the load. Test results showed successful application of the geotextile to stop water from rising to the subgrade via capillary action. Since this project is new, close monitoring is required to evaluate overall long-term roadway performance. However, as shown in Figure 2.16, preliminary observations indicate that the geotextile material has effectively served as a capillary break, wicking water out of the structural section.

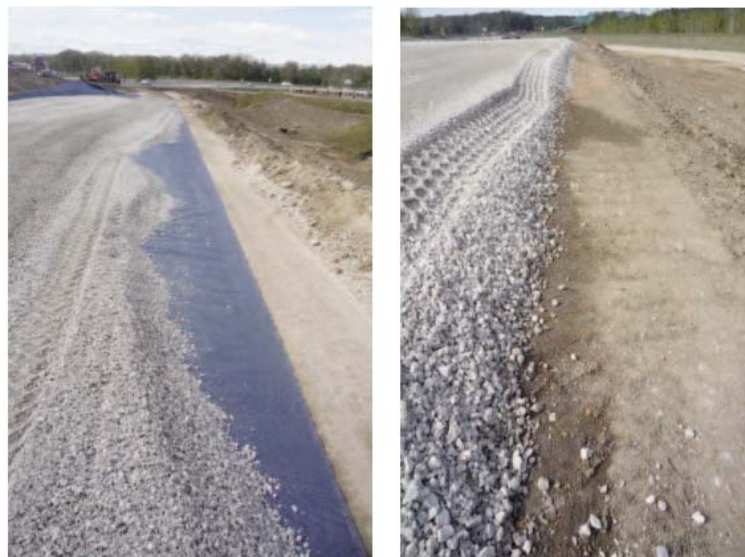
**Figure 2.17** Field observation at St. Louis County, Missouri

In this case, a new bridge was being constructed over the Missouri River. The objective in using the geotextile material was to remove water from underneath the pavement section. The original design was to construct a pavement section with 4 inches of base aggregate, 4 inches of drainable aggregate, and a prepared subgrade. It was expected that the geotextile could reduce the aggregate base material by 2 inches, and wick water from under the pavement. Observation is shown in Figure 2.17. The results proved that the geotextile successfully wicked water out of the aggregate.

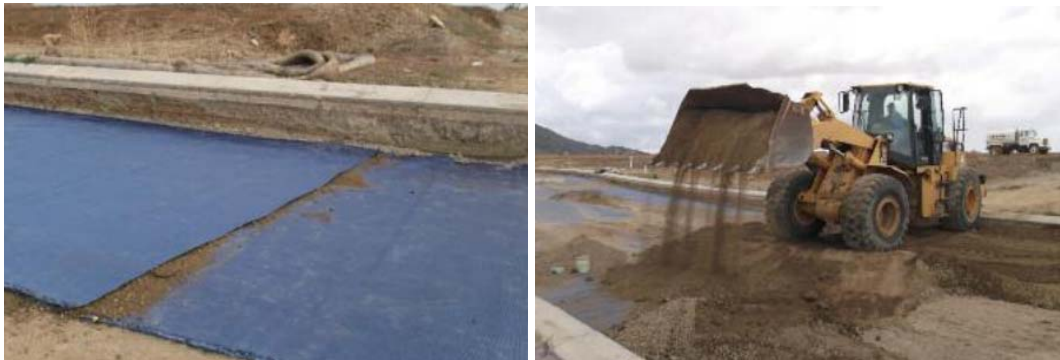
**Figure 2.19** Field construction at Corona, California

In Corona, California, a large section of roadway had become saturated by an excessive amount of natural water run-off, causing the roadway section to fail. The geotextile with wicking fabric was used to help drain away the excess water while providing enhanced stabilization (Figure 2.19). A 6-inch layer of base material was placed on top of the geotextile. A layer of geogrid was placed on top of that, followed by another 6-inch layer of base material. A 4-inch layer of AC was the final element of design to complete the road section. Observation indicated that the geotextile provided superior tensile strength at low strain for subgrade support, separated the natural subgrade

soils from the aggregate base, wicked excess water, and provided lateral confinement for the base section.

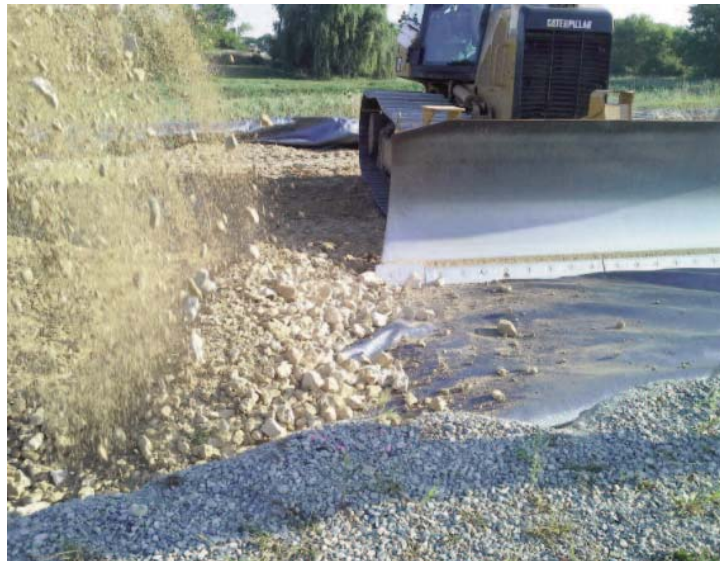
**Figure 2.20** Field construction at Jefferson County, Wisconsin

Another application of geotextiles occurred at Jefferson County, Wisconsin, where the material was used to solve a differential settlement problem. The primary challenge was the presence of wet and saturated silt and peat deposits to depths exceeding 30 feet below the existing pavement. Simply removing the deposits was not an economically feasible solution. The geotextile was directly placed on the exposed subgrade, followed by a 15-inch lift of crushed stone, a single layer of geogrid, and a 15-inch lift of crushed stone, as shown in Figure 2.20. The Jefferson County Highway Department reported that subgrade undercutting was minimized to 30 inches, compared with a potential 5–8 feet undercut (or more) for the soil conditions present. In addition to the cost savings, a substantial time savings was realized in the project construction schedule.

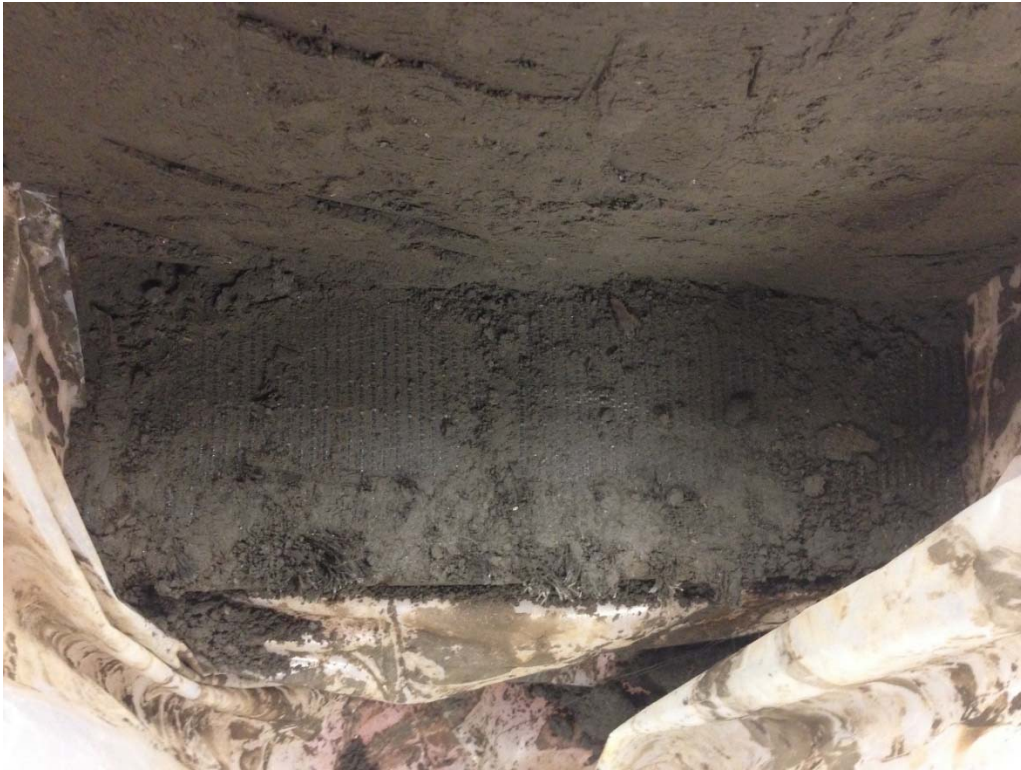
**Figure 5.6** Photo of organic silt and blinding of the fabric at the bottom

It is clear that organic silt has low permeability. Water added at the inlet end of the flume stabilized at about 8 inches and remained essentially at that height, clearly indicating that silt is impermeable and that the wicking fabric failed to transfer water. Photomicrographs were taken of a bundle of fibers at a magnification of 1500x. **Error! Reference source not found.** shows that the fibers were blinded by the small clay particles contained in the silt, which rendered the fabric ineffective.

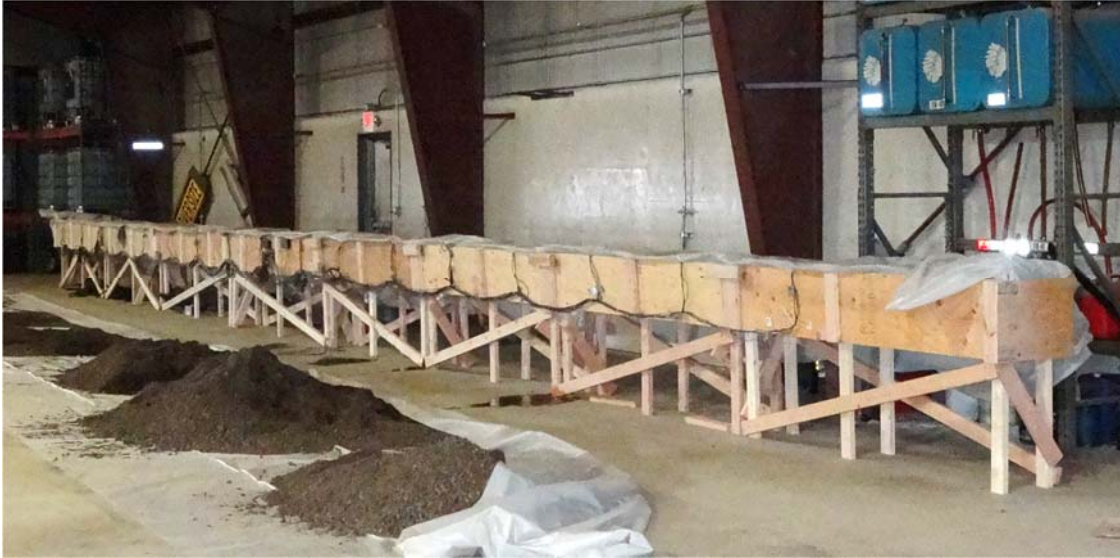
**Figure 5.7** 73-foot test flume

The application of H2Ri on airport runways requires the ability to transport water at least 75 feet for a 150-foot-wide embankment. To test the ability of the wicking fabric to meet that requirement a 73-foot flume was constructed (Figure 5.7). As in the previous tests, the flume was lined with 8 mil polyethylene sheeting that fully encapsulated the soil including the top.
